FREDERICK L. WALTERS  
Historical Architect • Architectural Conservator  
2752 Burton Lane, P.O. Box 437, Cambridge, Idaho 83610

Historic Stonebraker Ranch Barn

This letter report is presented as part of Idaho Heritage Trust's Technical Assistance Program. The report is based on the site visit of June 21<sup>st</sup>, 2017, and subsequent background research on the Stonebraker Ranch Barn. It will address what we have learned about the design development of the barn, its current condition, and address options for its future.

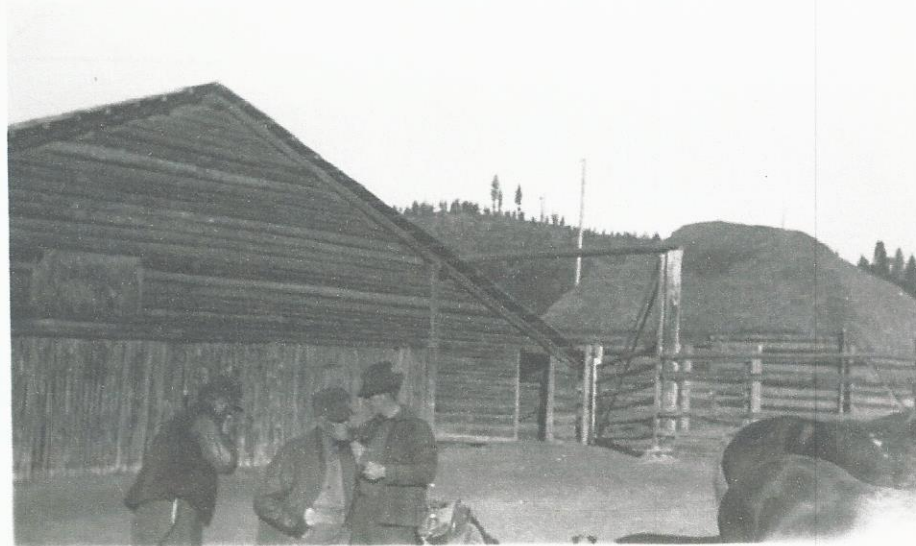
## Corral at Stonebraker Ranch

The first photograph shows three men in front of a corral barn with an open haystack in the background. It is dated 1903. Note the large pole at the back of the haystack.

The first two photographs indicated the barn was constructed in 1903.

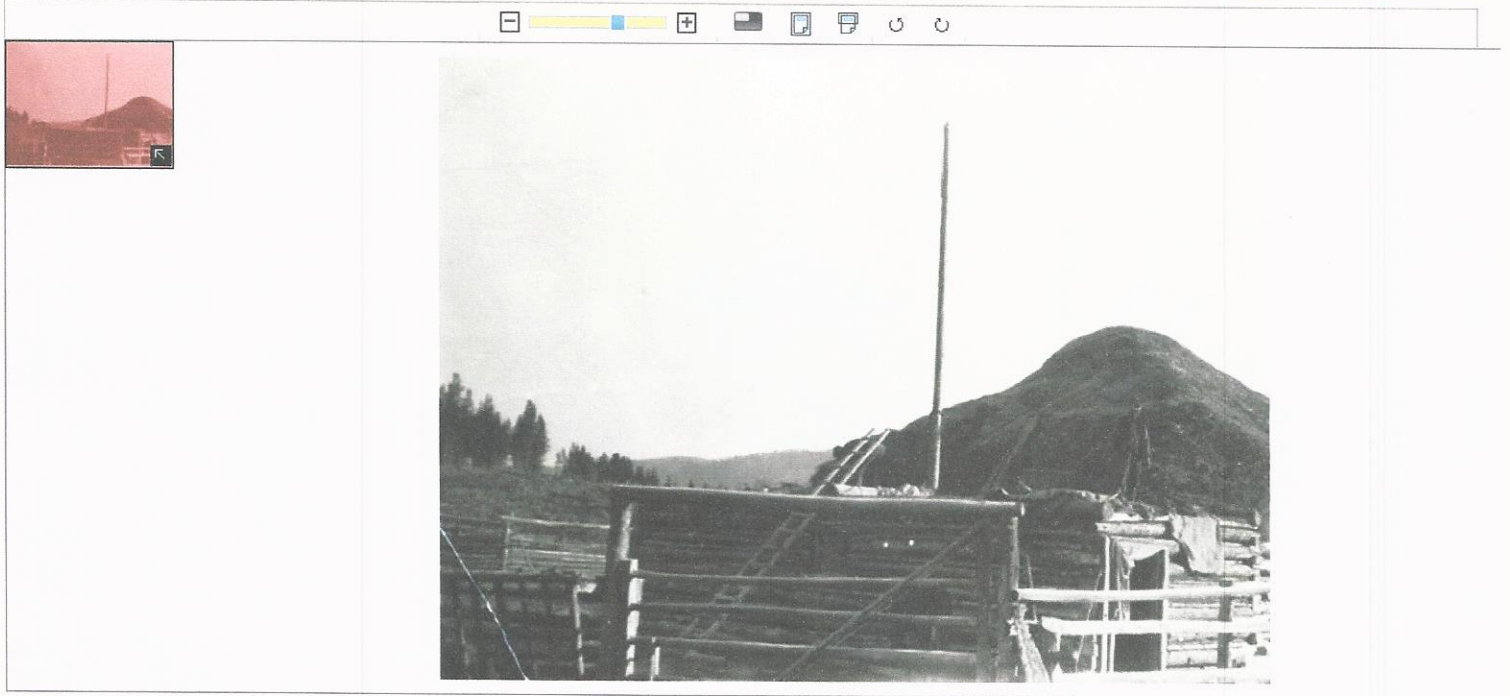
## Stonebraker Ranch Corral

The second photograph, also dated 1903, shows the large pole next to the haystack. It shows in the lower right hand corner the door entrance to the west side wing of the barn. The large pole is a gin pole (sometimes spelled "gyn"), a vertical pole used as a lifting

devise. Though the photograph caption says it is of a man standing on the roof of a log cabin, this picture shows the barn being built around the haystack. The gin pole was used to lift wall logs and roof structure into place.

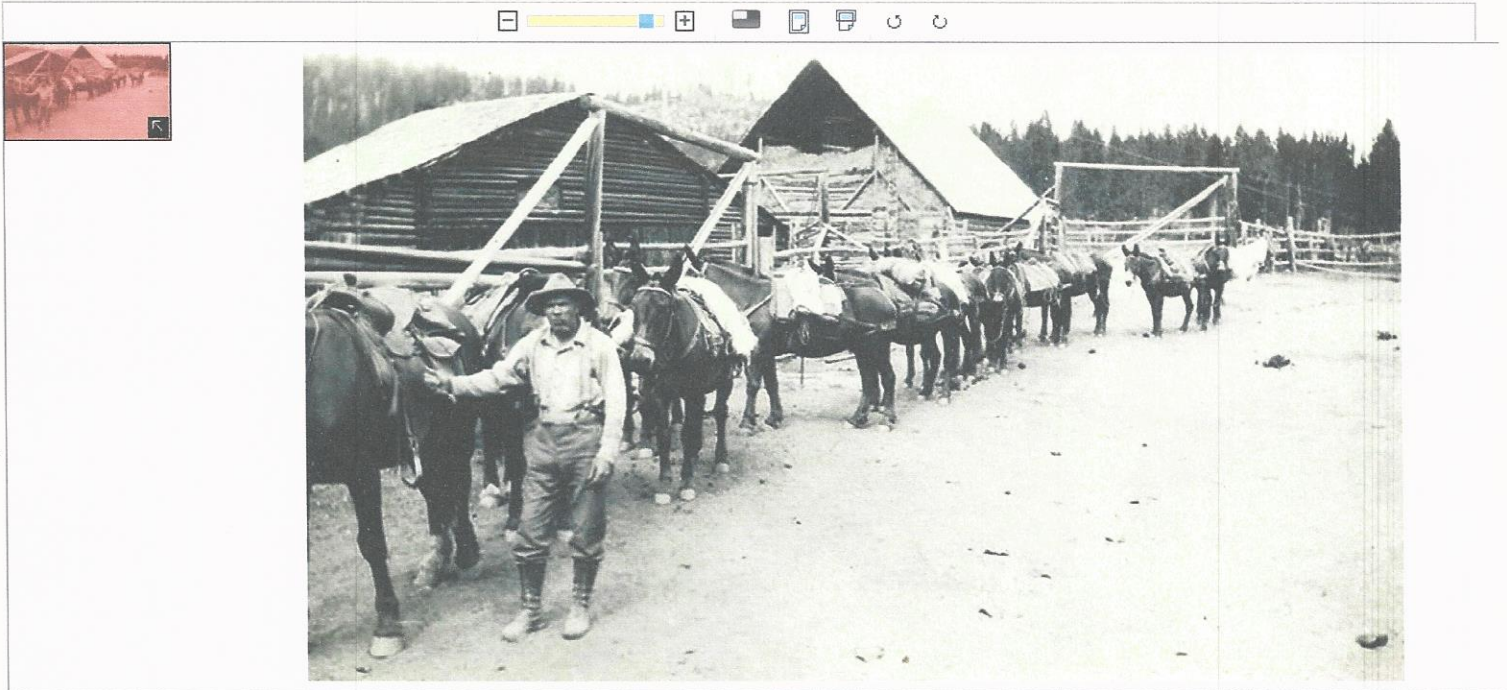
## W.A. Stonebraker and Mule Pack Train

The third photograph shows Mr. Stonebraker with the completed barn in the background, full of hay.
